Product recall Stubai ring piton and V-ring piton

Attention: there is a considerable risk of injury

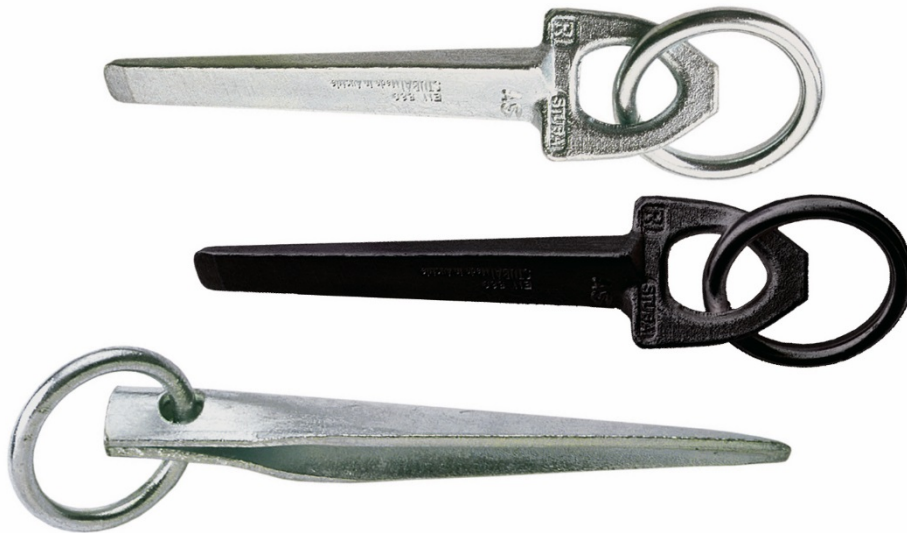
Stubai ring pitons with a welded ring can have too low breaking loads and must not be used further. The weld seam in the ring can be defective.

Only Stubai pitons with a welded ring are affected. All other products are not affected.

Pitons affected by the recall can be sent back to the distributor or directly to Stubai for inspection. The purchase price will be refunded.

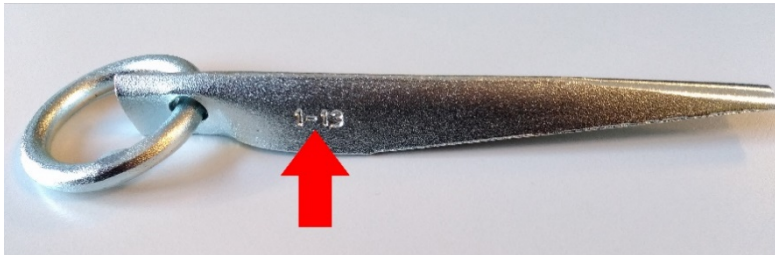
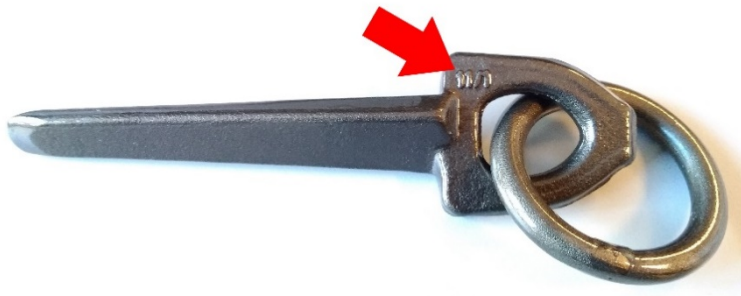
Batch number identification

With the batch numbers: 04/1, 10/1, 11/1, 13/1, 15/1, 17/1

With the batch numbers: 1-04, 1-10, 1-11, 1-13, 1-15, 1-17
